National Transportation Safety Board

Review of Recent Icing Accidents, Incidents, and NTSB Recommendations Regarding In-flight Icing

Daniel R. Bower, Ph.D.
Office of Research and Engineering

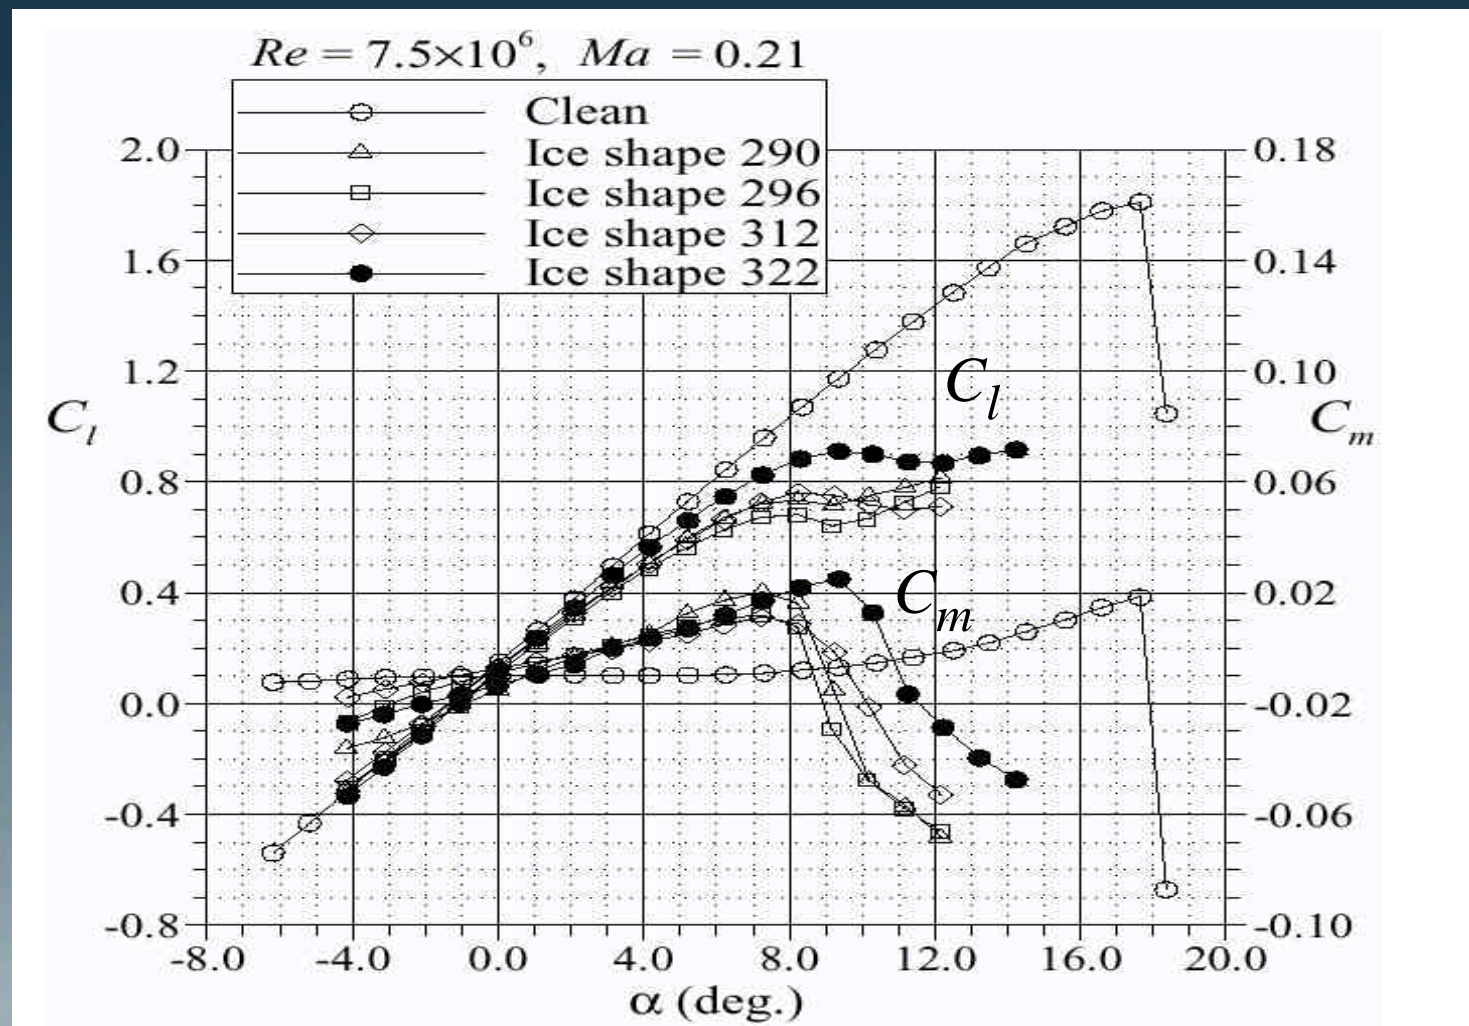
From Broeren, A.P., Addy, H.E., Bragg, M.B., "Effect of Intercycle Ice Accretions on Airfoil Performance"
AIAA-2002-0240
